# Honokowai Water Quality Management Plan

June 2016

Prepared for:  
NOAA Coral Reef Conservation Program

Prepared by:  
Horsley Witten Group, Inc.

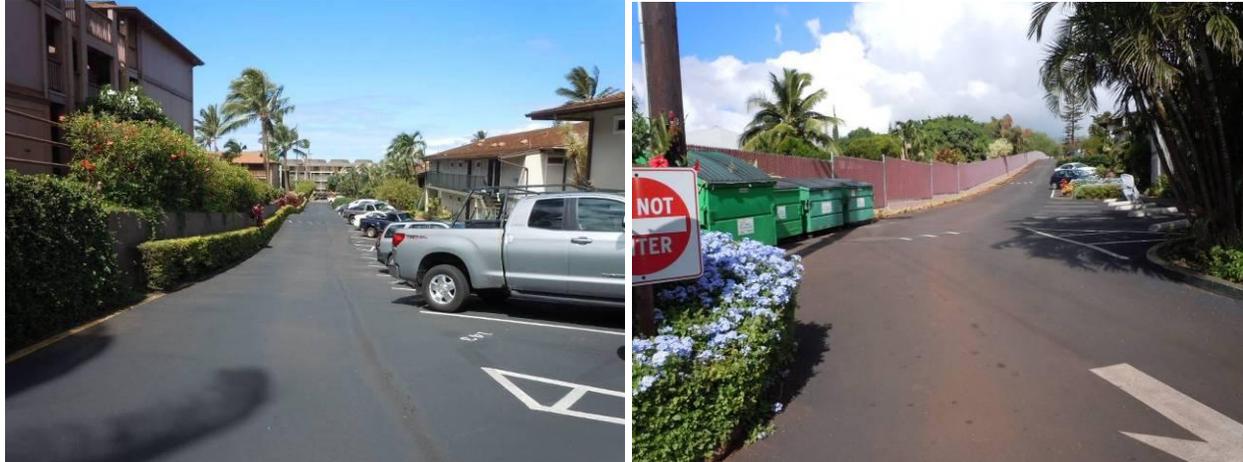
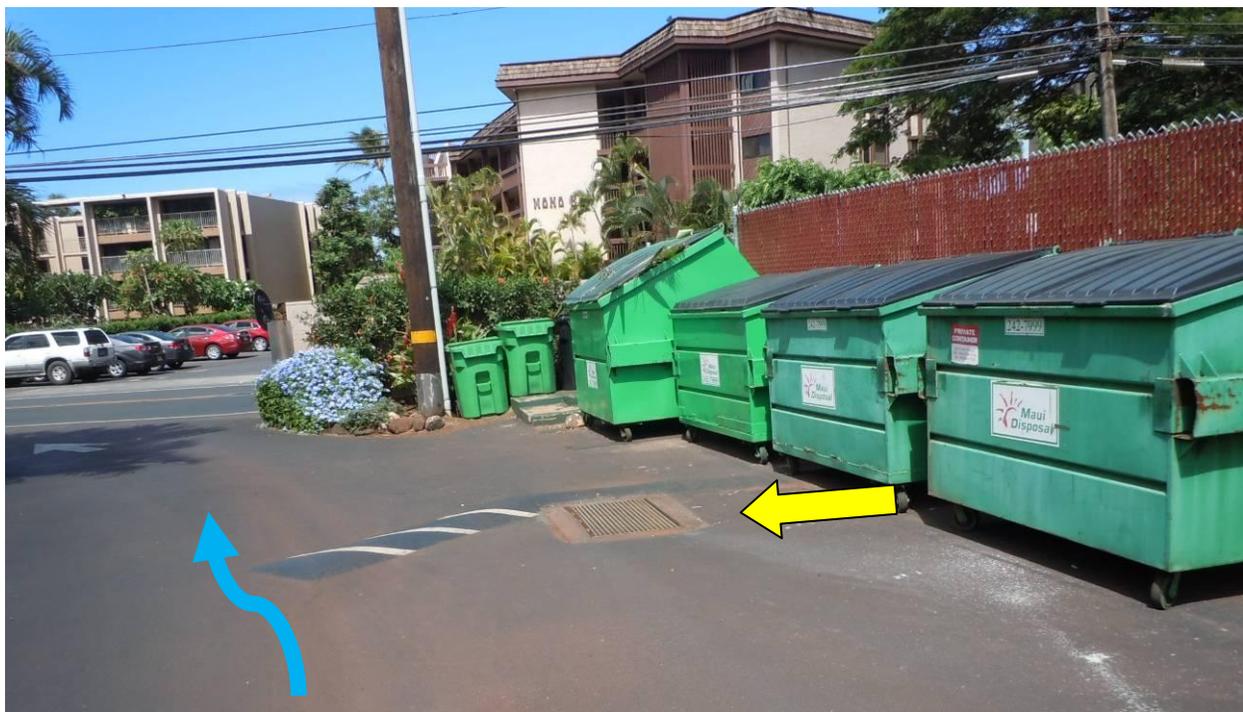
Looking downhill towards the entrance to Hale Royale (left); looking uphill from the exit (right).

This is the only catch basin to collect the stormwater runoff from the north side of Hale Royale. Sediment streaking on the pavement could indicate that runoff frequently bypasses this catch basin and enters the stormwater drain on Lower Honoapiilani Rd.

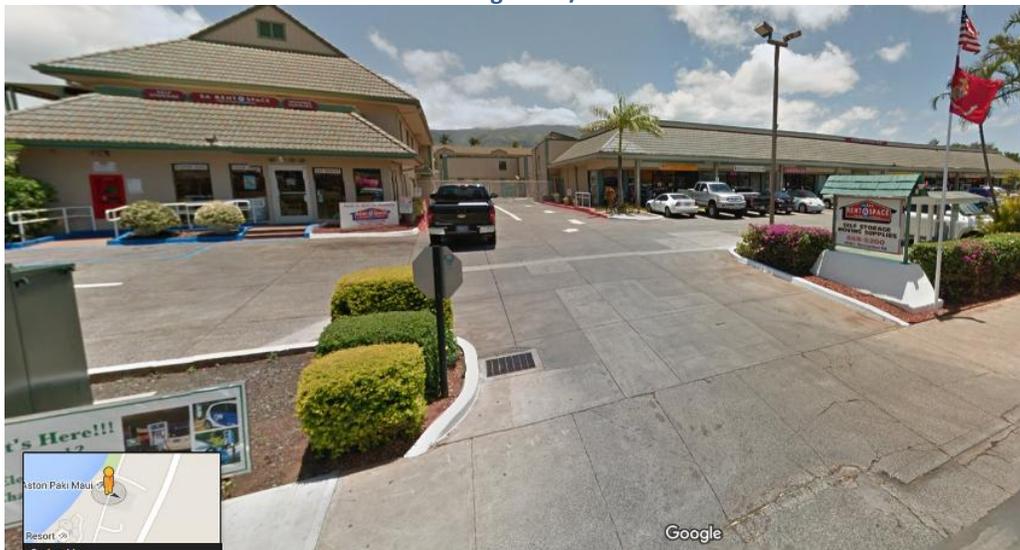
This commercial property was developed in 1987, and the majority of the property is comprised of storage units and associated parking area. The rest of the property consists of small stores and restaurants and their parking. The entire drainage network at this site was not observed since we did not gain access to the storage unit area, but the catch basin at the entrance was opened, and it was confirmed that this area contributes drainage to HBP-3. This property has the highest impervious cover in the watershed at over 90%, yet there does not appear to be any stormwater management on site.

**Entrance to the Storage Unit/Commercial Area.**

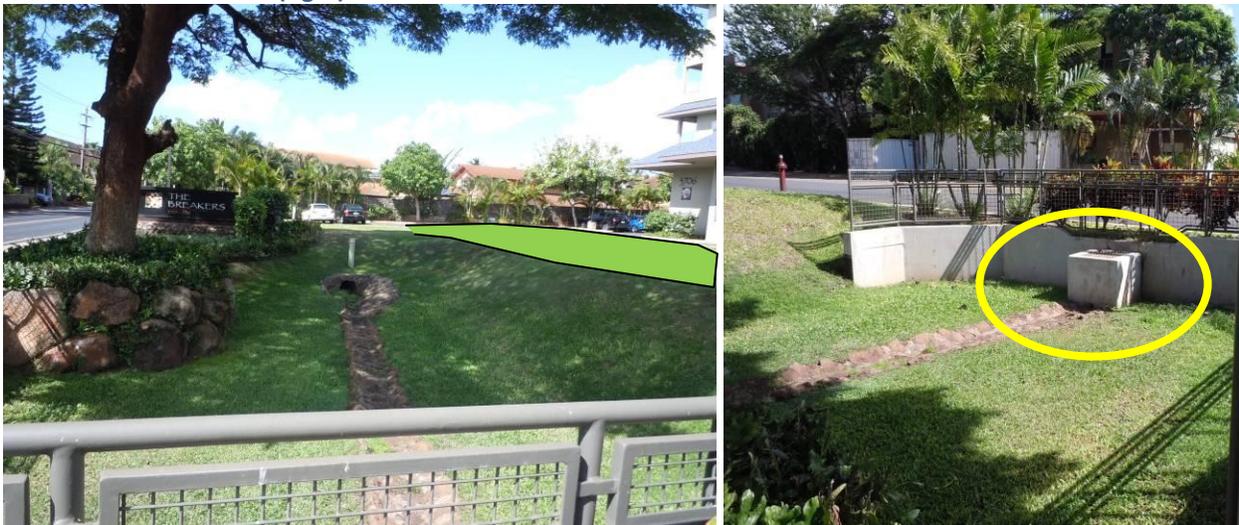
The Breakers is the newest development in the watershed (2008) and has the only observed stormwater BMP – an extended detention basin. There is a total of 2 acres of impervious cover that contributes runoff to the small basin immediately adjacent to Lower Honoapiilani Rd. This includes almost 1 acre of roof top that is directly connected to the parking area via downspouts discharging to the pavement. Runoff is collected by a series of catch basins and directed into the detention basin. Low flows are conveyed with a hardened (appears to be a mortared rock base) low-flow channel with little to no detention before flowing out the orifice in the overflow structure. Runoff from larger storm events will be detained in the basin until the water reaches the top of the overflow structure, where it will flow through the grate and into the storm drain system in the road. The proposed retrofit for this site is to enlarge the existing basin utilizing the open lawn next to the basin (currently slated for future development), providing water quality treatment features such as a sediment forebay for pretreatment, longer flow path for low flows, wetland vegetation to filter and take up nutrients, and greater flood storage for larger events. In addition, the rooftop runoff should be collected in cisterns and reused as much as possible. Allowing the clean roof runoff to flow over a parking lot, picking up all the associated pollutants, is a lost opportunity. This could also provide a good example for other developments in the watershed – almost all buildings have gutters and downspouts for roof runoff, and yet no cisterns or rain barrels were observed. This project does have potential for public education given its location next to the main road, but it is a private development where future buildings are proposed, presenting an implementation challenge.

Looking down the low-flow channel in The Breakers existing detention basin with the proposed basin expansion indicated in green (left); overflow structure for the detention basin showing a low-flow orifice at the same elevation as the channel (right).

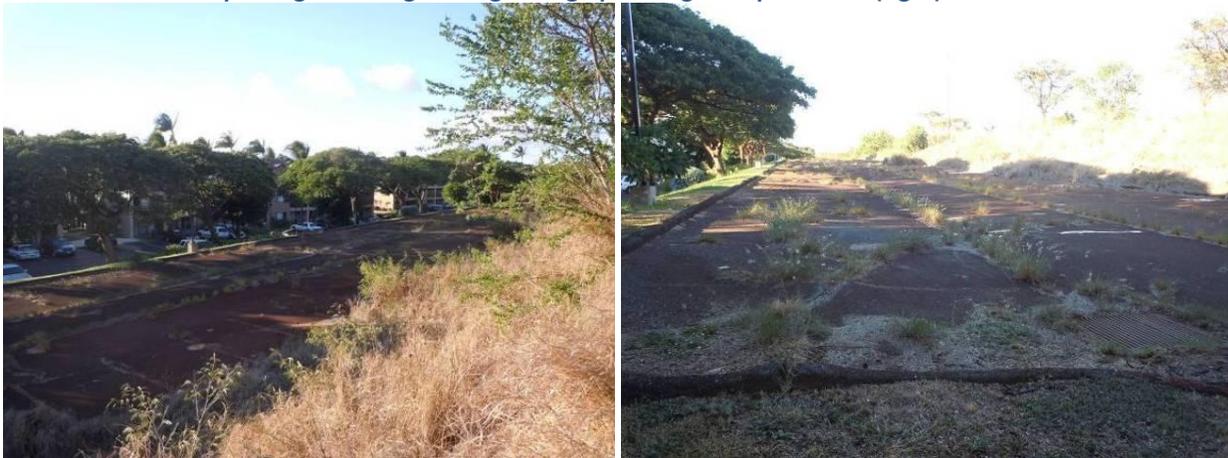
This 3.8-acre property is located at the top of the watershed next to the Honoapiilani Highway. Much of the site is pervious, except for a 0.9-acre abandoned parking lot. This parking lot is not completely impervious with many cracks where vegetation has started growing. However, we assume that it still creates runoff during larger storm events, adding to downstream flooding and water quality issues. This property presents a great opportunity to revegetate in a highly urbanized, impervious watershed. This area could also be converted into a park with walking paths and picnic tables for the many nearby residents of Sunset Terrace, Honokowai East, West Maui Trades, The Breakers, and more. Pavement removal and revegetation is relatively inexpensive compared to other stormwater retrofit opportunities in the watershed; however, the State ownership of this property could present a challenge if the land is slated for a different purpose. That being said, the State could also be a great partner in this and other projects in the watershed.

Looking down at the abandoned parking lot from the shoulder of Honoapiilani Highway (left); many cracks are visible in the former parking lot with grasses growing up through the pavement (right).

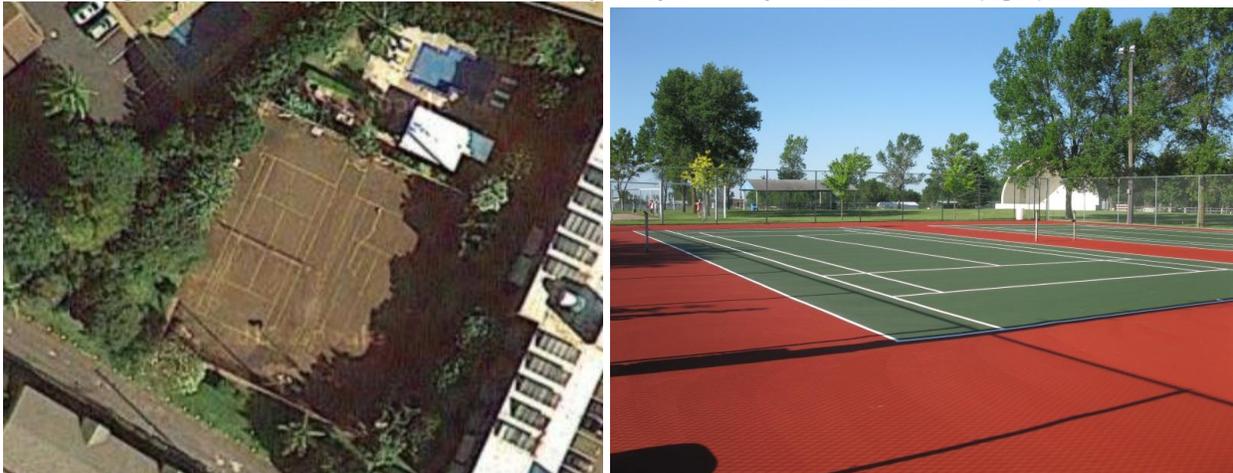
This condominium complex has tennis courts for its residents to use. The courts are impervious (~12,000 sf) and in need of repair/repaving. The impervious surface could be replaced with a permeable material such as permeable asphalt, porous concrete, or a more flexible permeable surface made of recycled rubber. This type of material could also be used at the other tennis courts in the study area – Hale Royale. While this proposed retrofit would manage runoff from over 20% of the Honokowai East property, it is located on private property and presents little opportunity for public education other than for the condominium residents.

The existing courts at Honokowai East (left); an example of porous asphalt tennis courts (right).

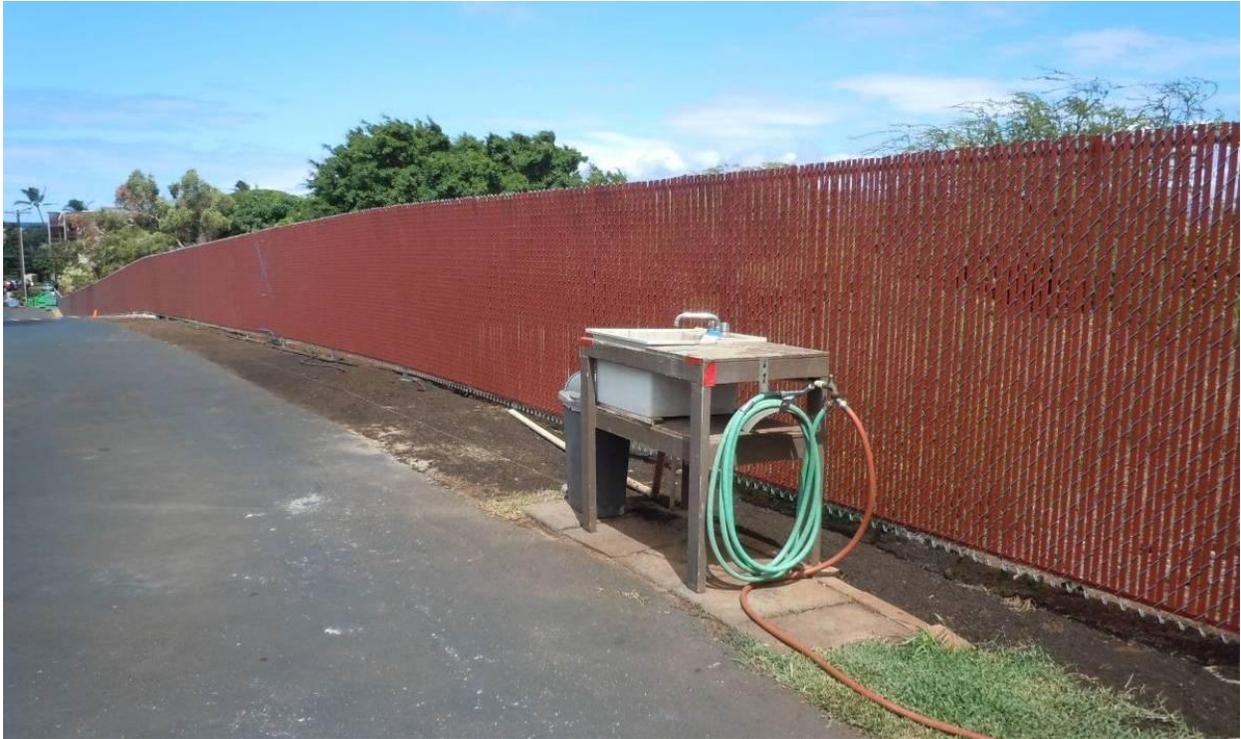
This utility sink next to the laundry building at Hale Royale discharges on exposed soil and then down the steep driveway to a catch basin at the intersection with Lower Honoapiilani Hwy.

- Wash water—Wash water should be properly disposed of rather than allowed to enter the storm drain system. Dirty mop buckets contain gray water and should be dumped into a sink connected to the sanitary sewer. Car wash areas should not discharge to the storm drain system without some form of advanced treatment or they should be connected to the sanitary sewer system.

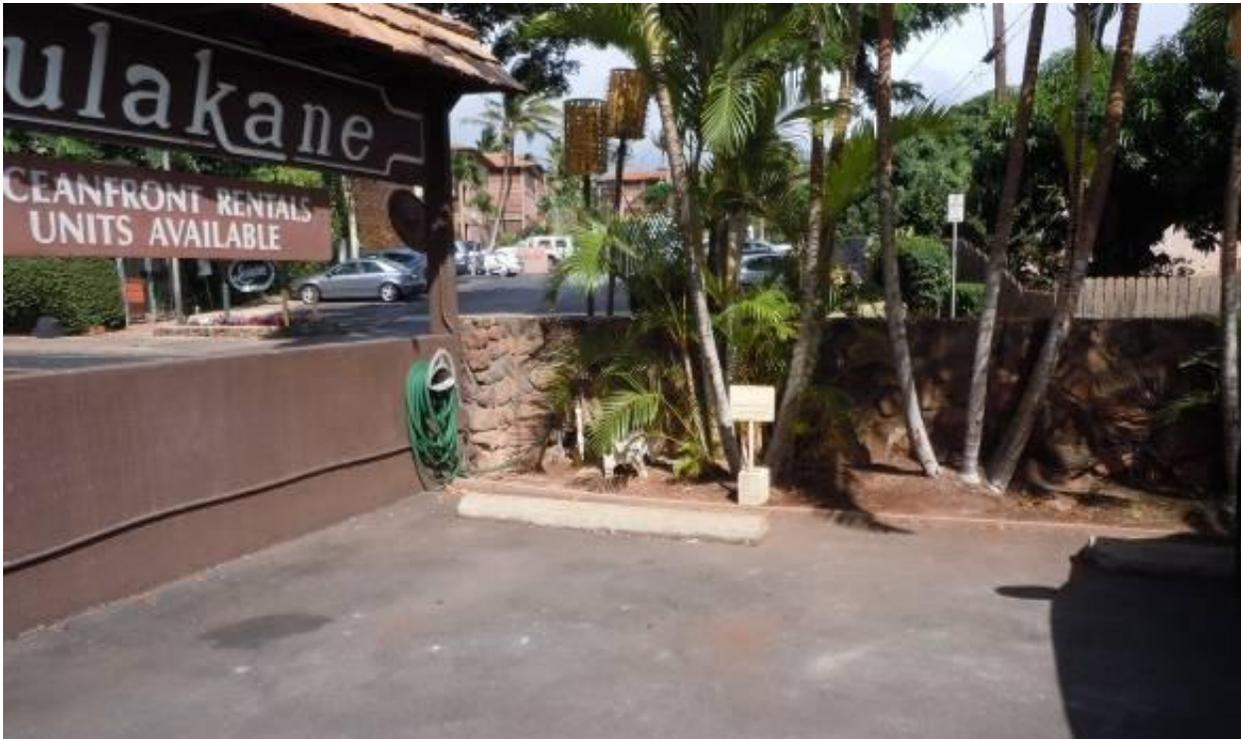
This is the identified (see sign) "Car Wash Station" at the Kulakane. Runoff from this area flows to the low point in the parking lot and out into Lower Honoapiilani Rd.

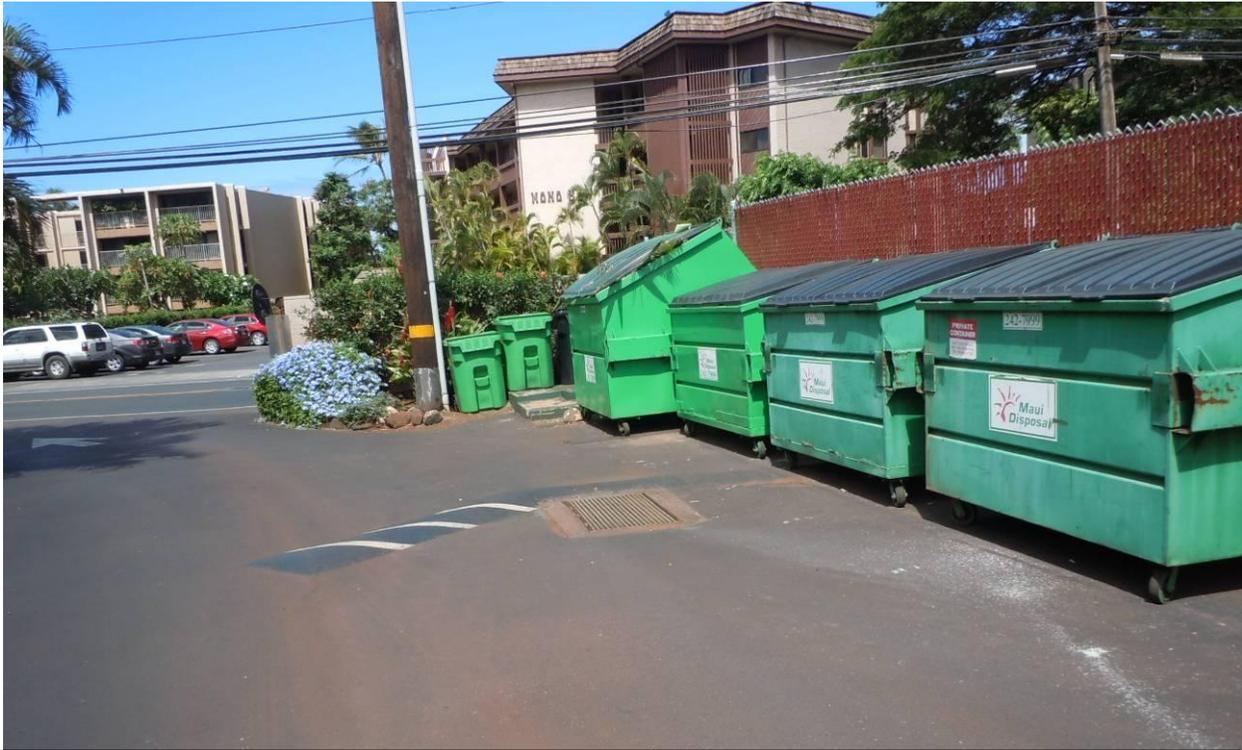
All of the dumpsters for this large complex (Hale Royale) are located right next to this catchbasin. The dumpsters do have lids, but there is still a risk of “dumpster juice” leaking directly into the storm drain.

- Improved dumpster management—Covers reduce the amount of direct rainfall onto materials and secondary containment provides a barrier to leaking containers. Most dumpsters in the watershed did have covers, but almost all of them were located right next to catch basins. Moving dumpsters away from catch basins is a relatively inexpensive solution.

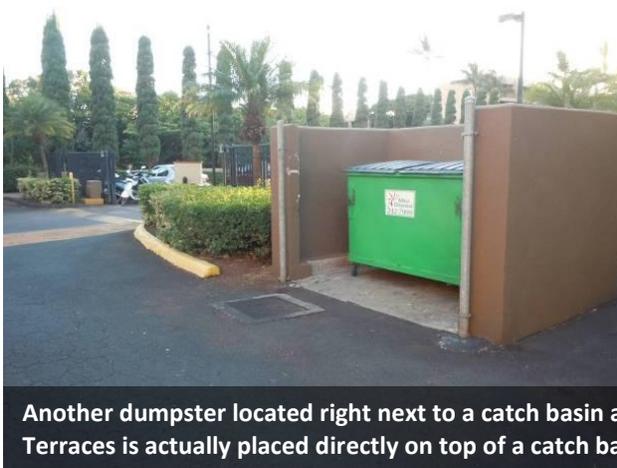
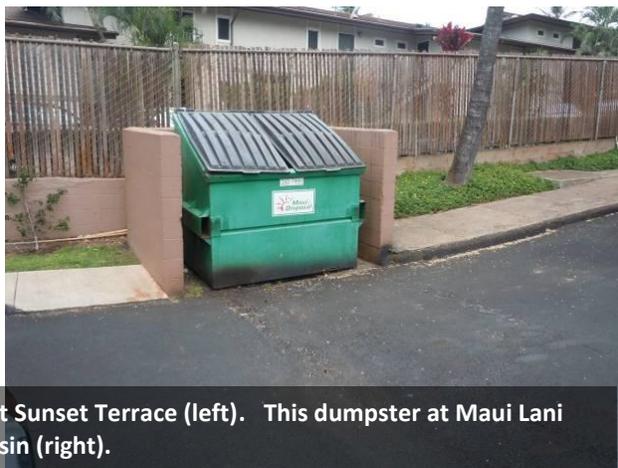
Another dumpster located right next to a catch basin at Sunset Terrace (left). This dumpster at Maui Lani Terraces is actually placed directly on top of a catch basin (right).

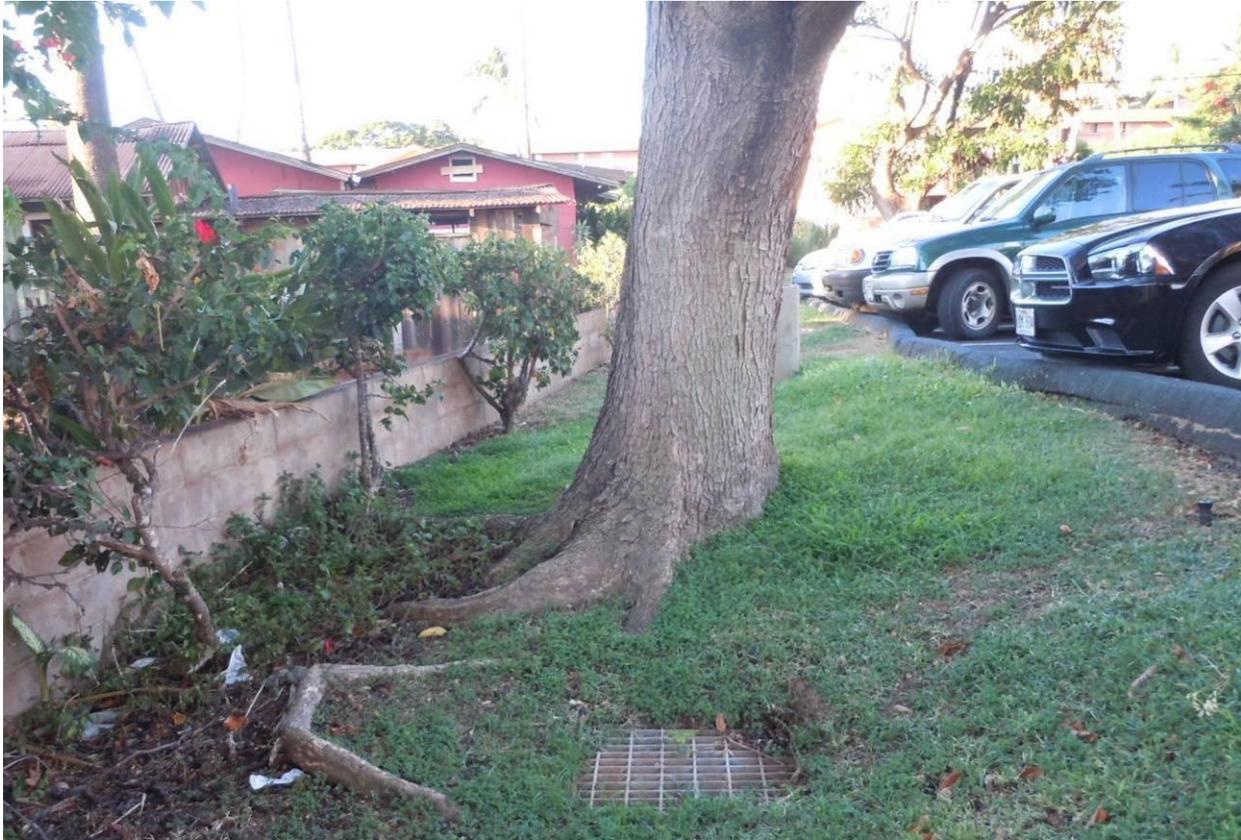
This catch basin is located in the landscaping area at Sunset Terrace near the back of the Farmer’s Market Plaza. Flat grates like this one are easily clogged by vegetative debris, which can lead to flooding issues as well as adding more nutrients to the stormwater system.

- Proper landscape management—Homeowners and property managers should reduce the amount of fertilizers, spray irrigation, pesticides, or other chemicals applied to turf and landscaping. Landscaping debris should be kept out of the storm drain, and pet waste should be picked up in areas where dogs are frequently walked.

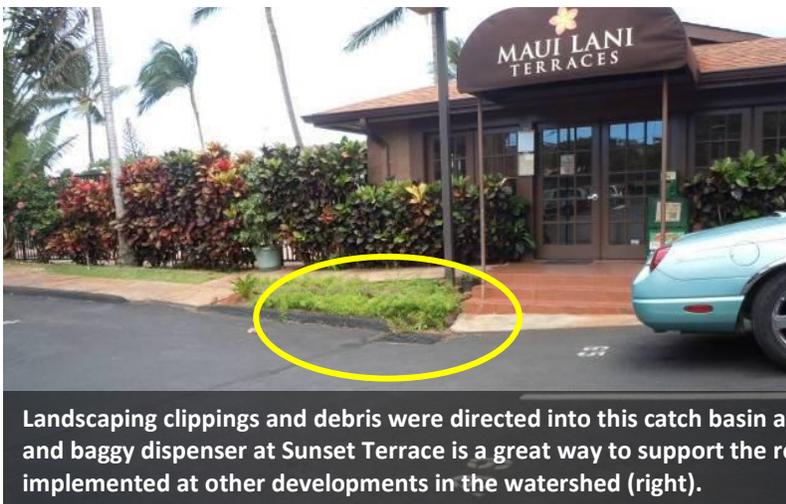
Landscaping clippings and debris were directed into this catch basin at Maui Lani Terraces (left). This sign and baggy dispenser at Sunset Terrace is a great way to support the removal of pet waste and should be implemented at other developments in the watershed (right).

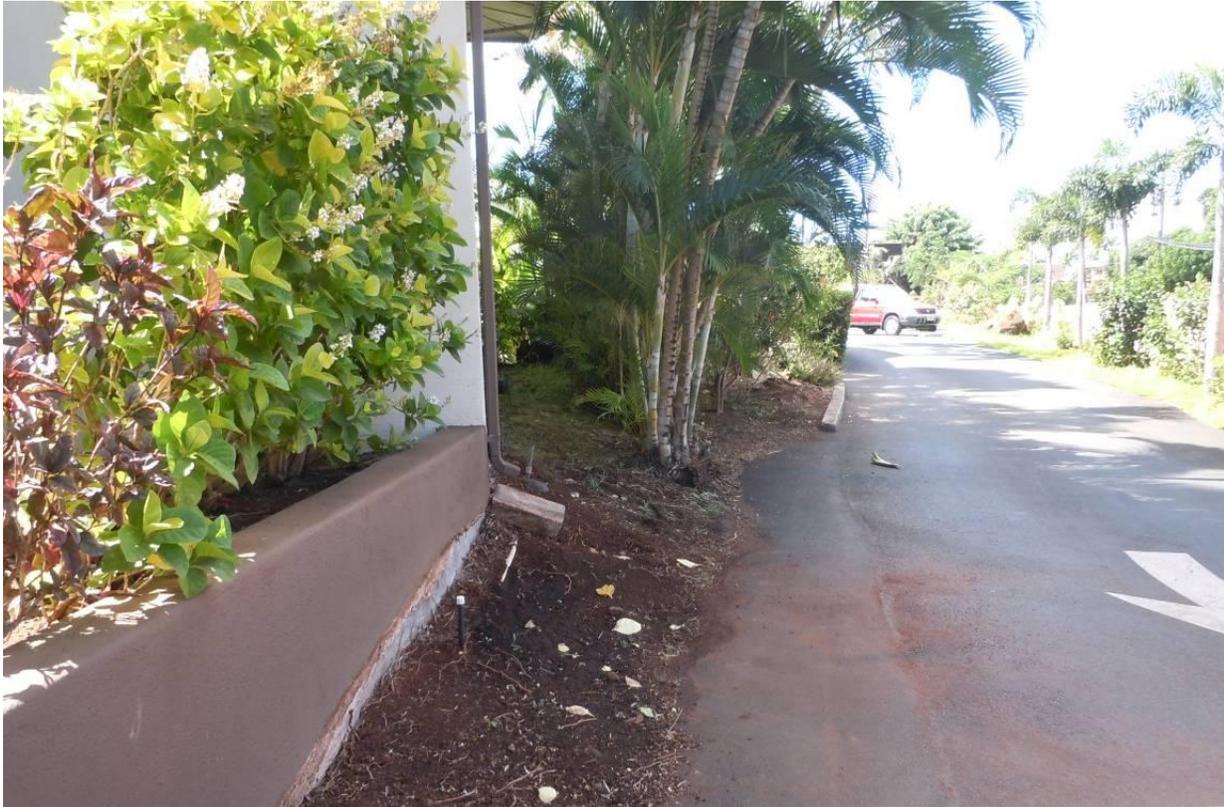
This downspout at Hale Royale discharges roof runoff onto exposed soil, which then is eroded and carried into the driveway and out into the street.

- **Soil Stabilization** — When bare soil is exposed to rainfall, the soil will erode and lead to sedimentation of downgradient stormwater structures and eventually streams and coral reefs. Bare areas should be stabilized as soon as possible with vegetation or rock to prevent sedimentation.

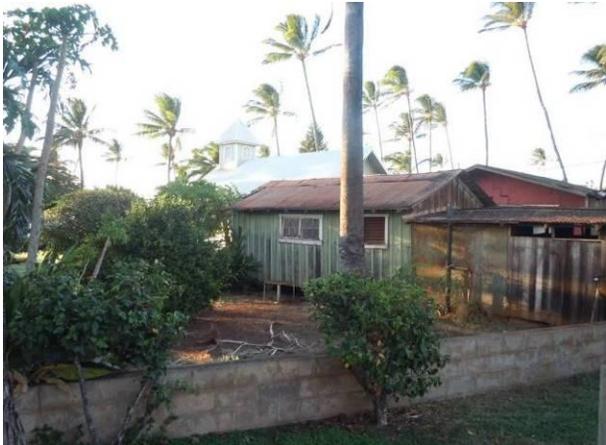
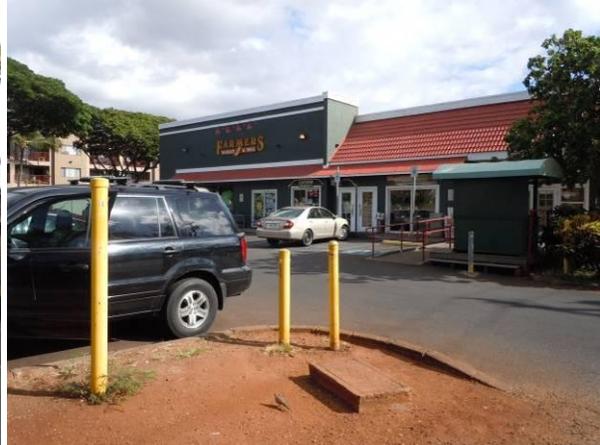
This property behind the Lahuikalani Church (left) and a parking lot bump out at the Farmer’s Market Plaza (right) both have areas of exposed soils that are contributing sediment in this watershed.

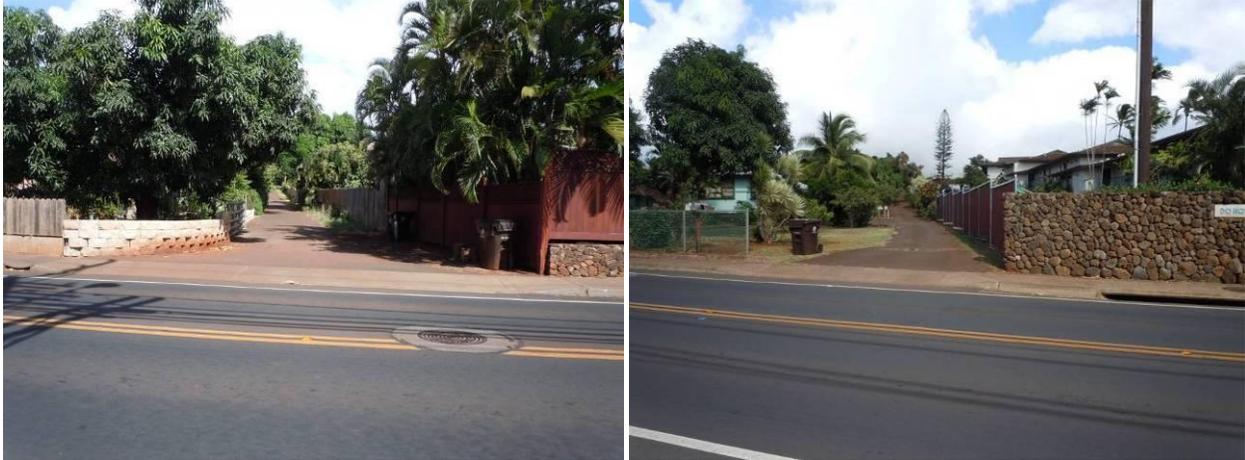
Sediment staining indicates soil erosion from these private residential roads between Maui Lani Terraces and Haku Hale Place (left) and north of Hale Royale (right).

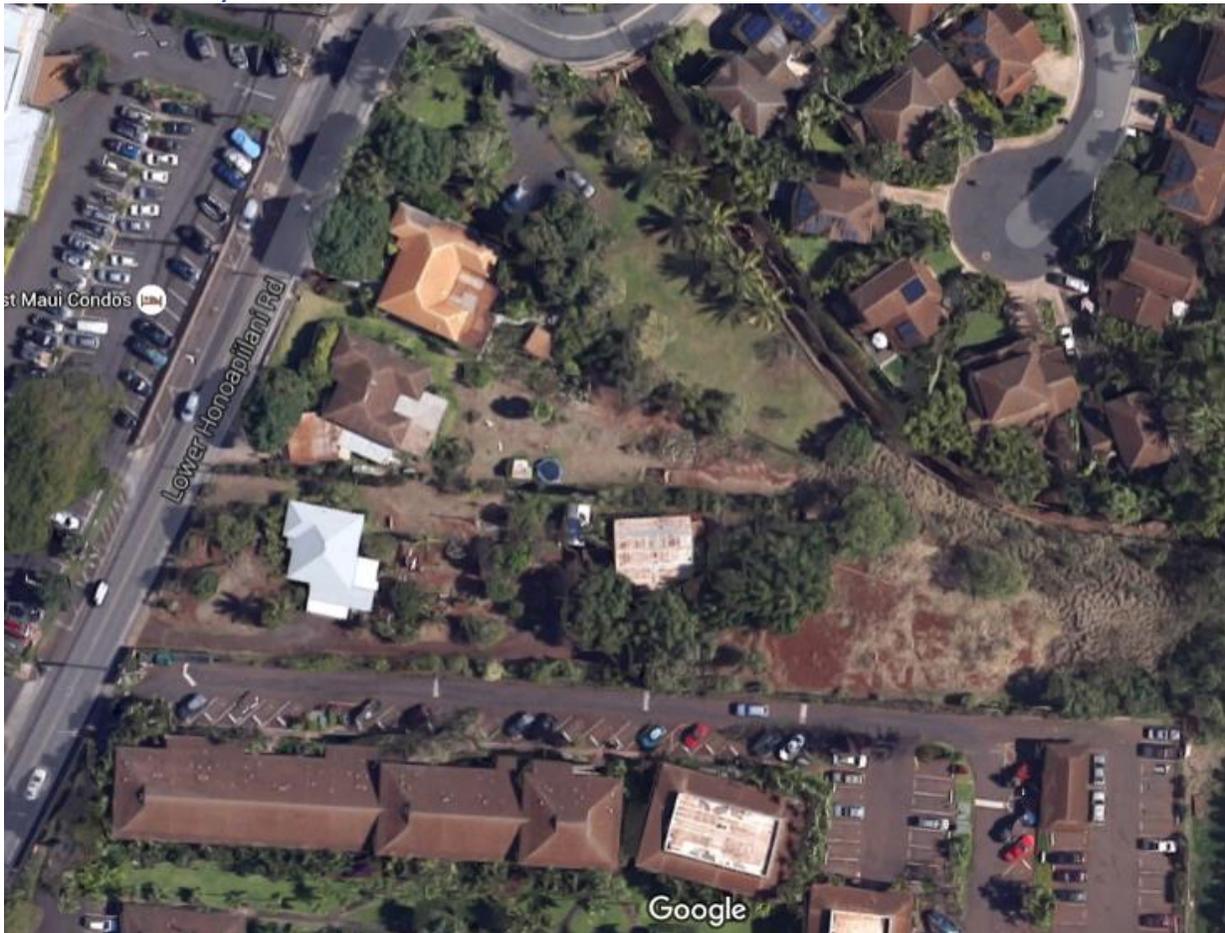
The aerial from Google Earth shows the extensive areas of exposed soil in the single-family residential area to the north of Hale Royale.

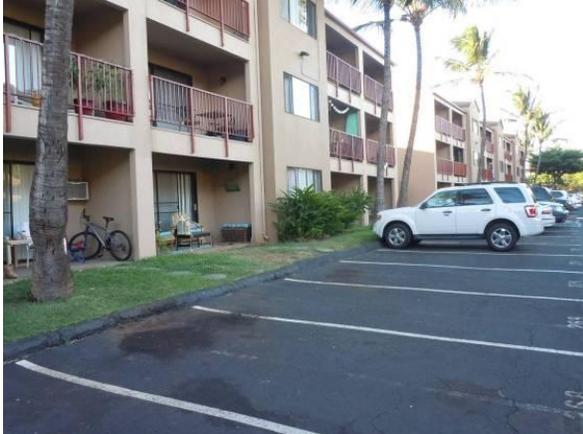
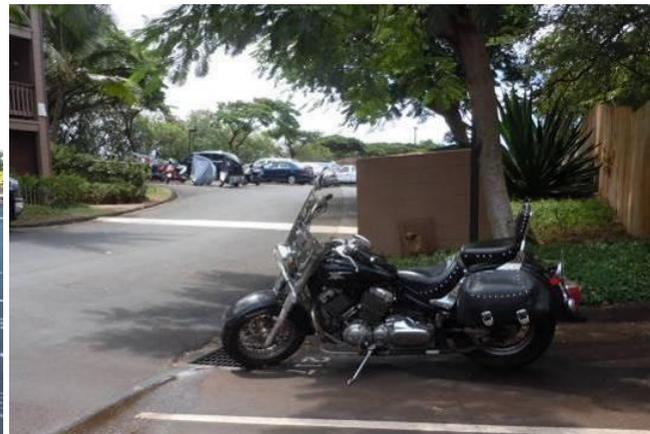
Oil stains are visible on the parking lot near a catch basin at Sunset Terrace (left); a motorcycle is being stored on top of a catch basin at Maui Lani Terraces (right).

- **Vehicle Maintenance** — Many of the residential developments had areas in the parking lots where vehicles (cars, boats, motorcycles, etc.) were being stored and/or maintained. Drippings from vehicles then flow into the storm drain. Residents should be encouraged to either take their vehicles to a shop for maintenance, or perform oil changes and other activities in an area far from a storm drain and properly clean up and dispose of supplies.
