KĀ'ANAPALI RESORT LAGOON FLOATING WETLANDS: CASE STUDY

Prepared by Roth Ecological Design International, LLC

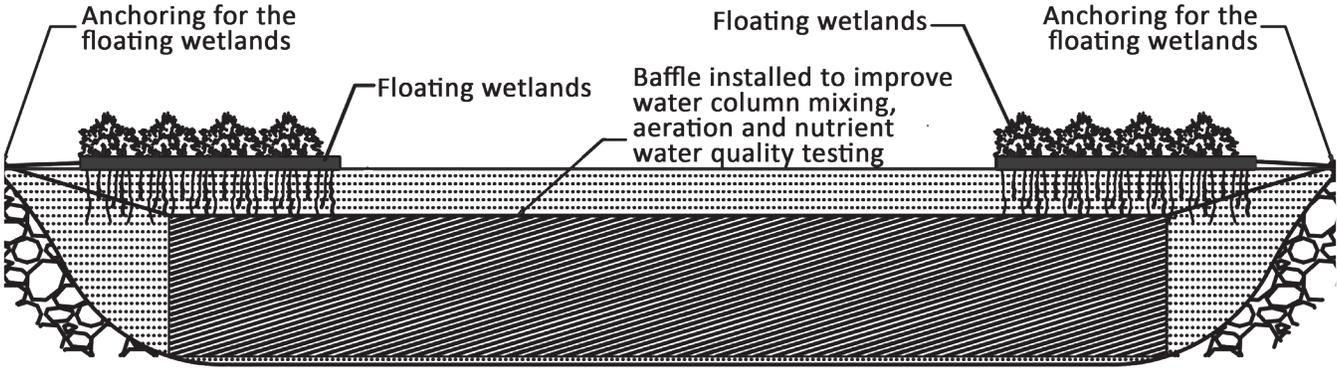
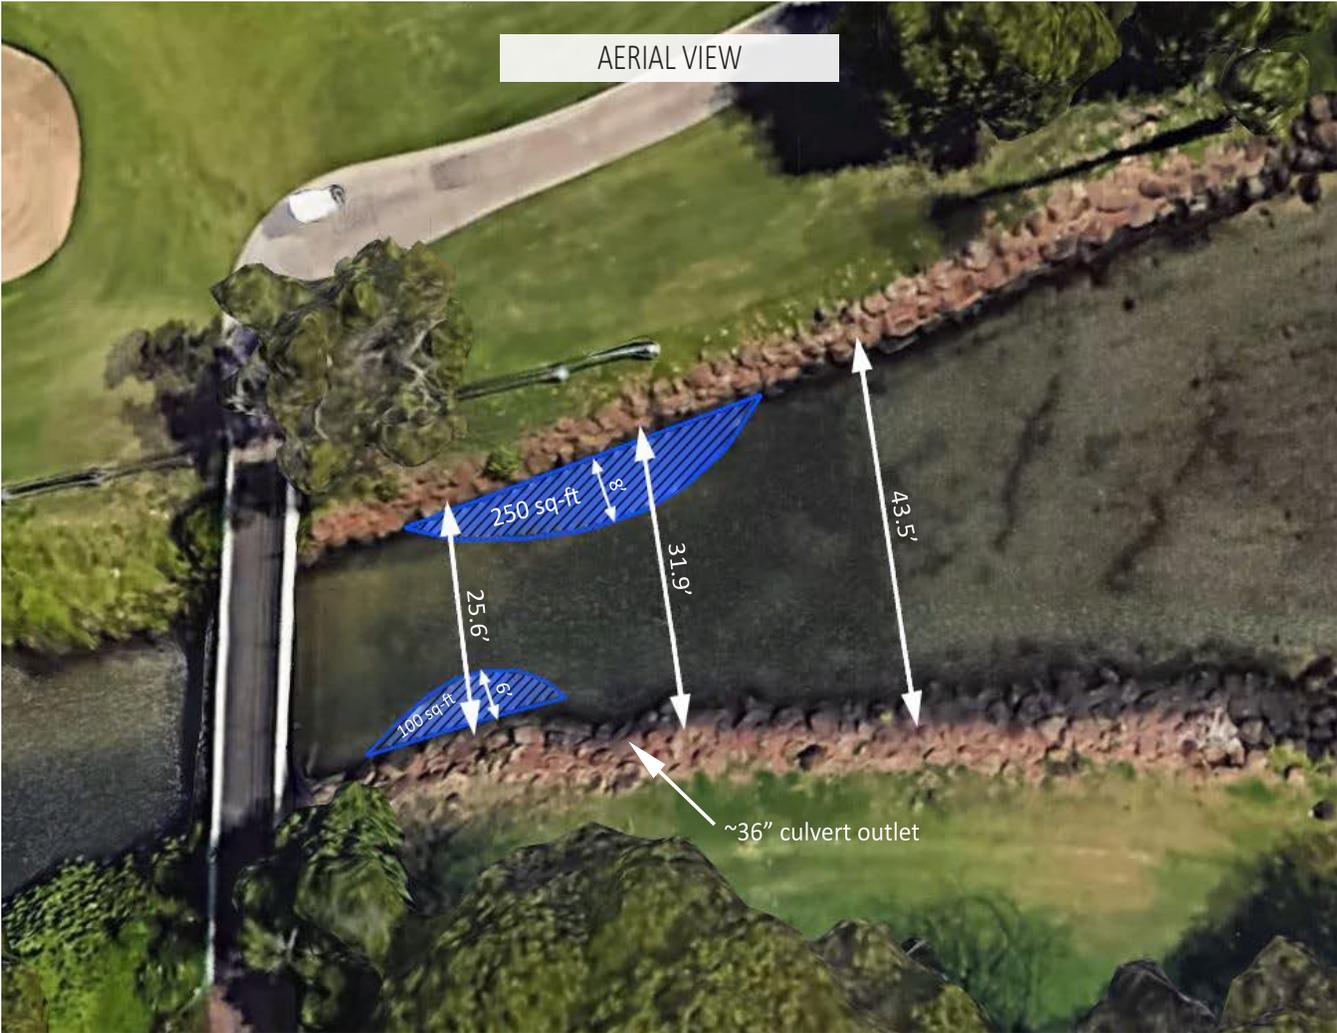
SECTION VIEW OF THE FLOATING WETLANDS

The floating wetland media allows for >300 square feet of surface area per cubic foot, which combined with the native Hawaiian wetland plants, provides habitat for the wetland ecology to remove nutrients and clean the water before it enters the ocean. This help protect the reefs and maintain good water quality for everyone to enjoy. In addition to the wetlands, baffles were installed to promote mixing and associated oxygenation of the water column. The baffles were also designed to help "retain" the canal water around the wetlands for monitoring of potential nutrient removal.

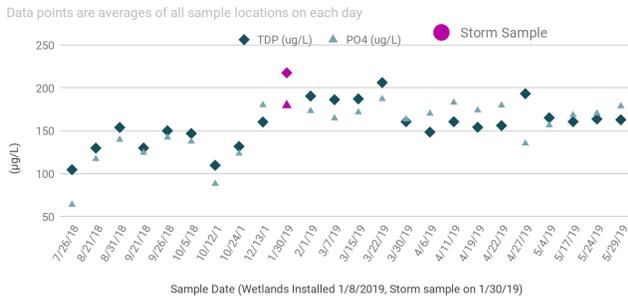
Phosphorus in Lagoon over time

Baseline water quality was taken in the fall of 2018 and compared to post installation of the floating wetlands. There was no statistical difference of nutrient removal found between before and after results and between the different sites. This seems to indicate that the water is well mixed and that the regular tidal influence may have affected the residence time needed to show significant nutrient results. In addition, typically a pulse of nutrient influx would occur during the initial period of a storm event and the timing of sampling likely missed this “first flush” effect. Moreover, water quality testing post installation of the wetlands occurred only during the first six months

after planting. Typically as the ecology becomes more established (and has greater biomass) more nutrients are extracted. In their review of nutrient removal in floating wetland plants, Pavlineri et al. found significant evidence showing that “successful biomass establishment seems to linearly and predominantly correlate to efficient nutrient removal rates” (2017). The literature also shows that nutrient allocation (aerial tissue vs. roots) and nutrient uptake rates vary seasonally.

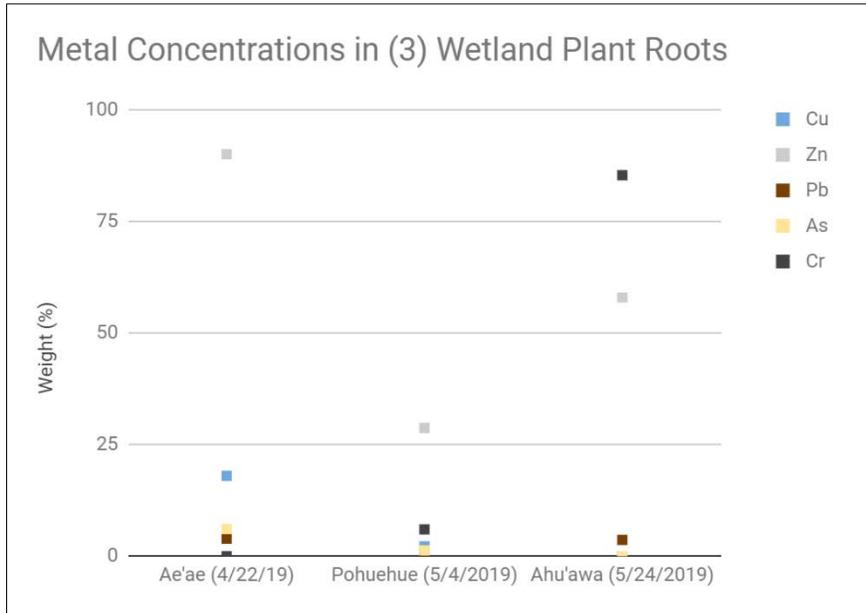
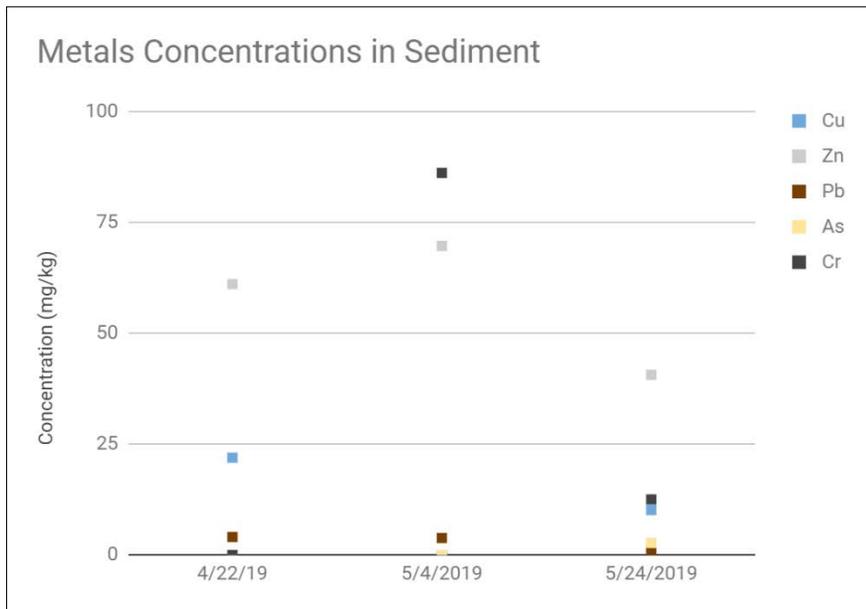
Metals were sampled from the water column, stormwater culvert inlet, sediment in the channel as well as within the roots of three of the floating wetland plants. Initial results indicate that the heavy metals were present in sediment and generally nondetectable in the water column, which was to be expected since metals tend to bind to sediment particles. Although it would require more research to conclude, initial metals results from the floating wetland plants' roots, indicate that the plants may be undergoing phytoremediation by trapping sediments and taking up of the heavy metals.

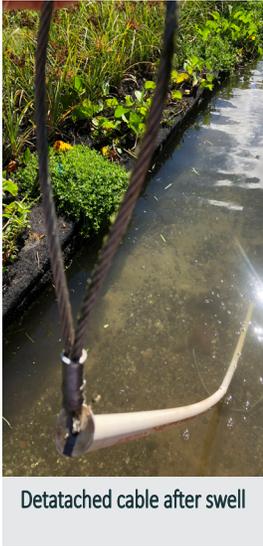
Detatched cable after swell

The wetlands were placed in a location that is susceptible to strong tides, ocean swells and storm surges. Although stainless steel cables and moorings were used, following large swells, some cables and moorings snapped. The intensity of ocean swells in the canal to break cable specified for >4000 lbs of force was unexpected. Locating wetlands in areas with less extreme ocean forces would be recommended in the future.

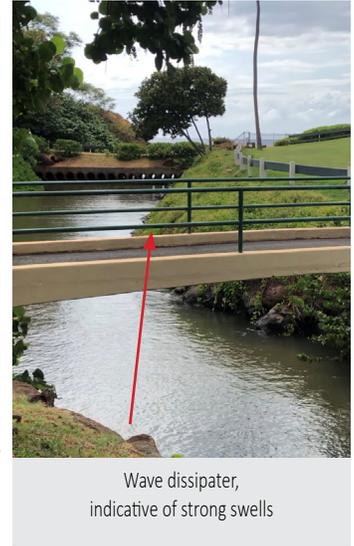
Wave dissipater, indicative of strong swells
