# Honokowai Water Quality Management Plan

June 2016

Prepared for:  
NOAA Coral Reef Conservation Program

Prepared by:  
Horsley Witten Group, Inc.

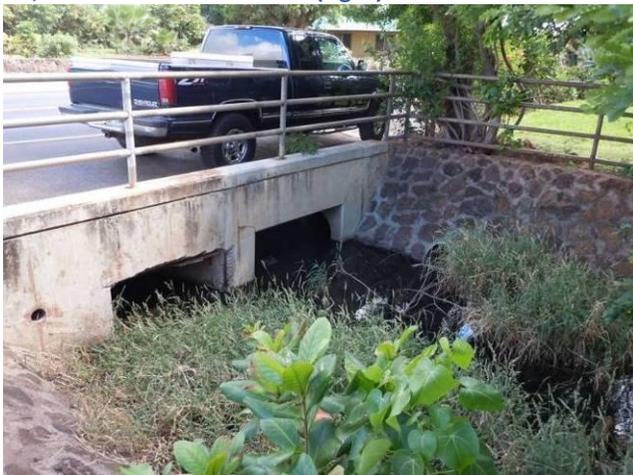
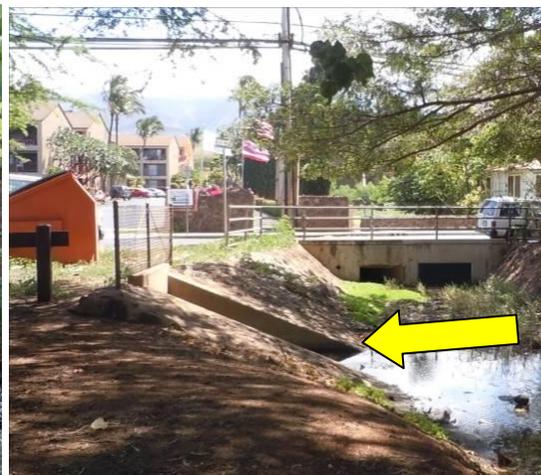
**HBP 2 and 3 are box culverts under Lower Honoapiilani Rd (left); HBP 1 is a large box culvert under the parking lot, indicated with an arrow (right).**

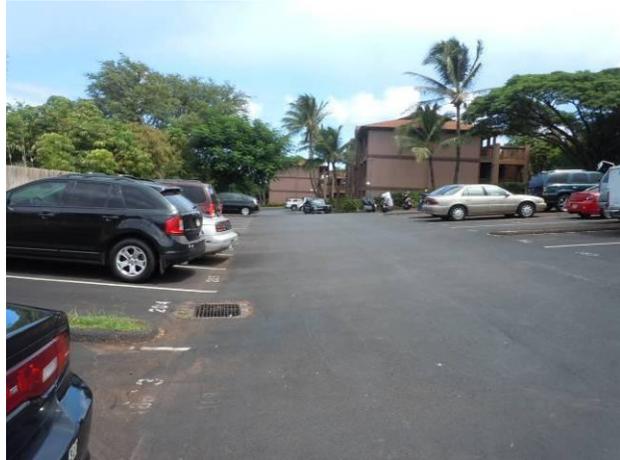
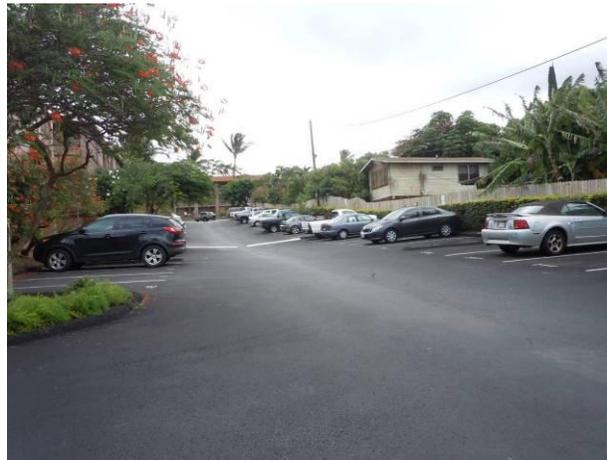
The upper parking lot at Maui Lani Terraces showing the extensive pavement and a catch basin at the low point (left); looking uphill from near Leinani Apartments (right).

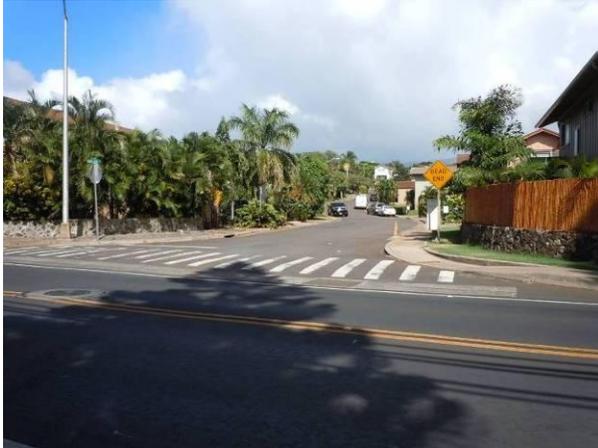
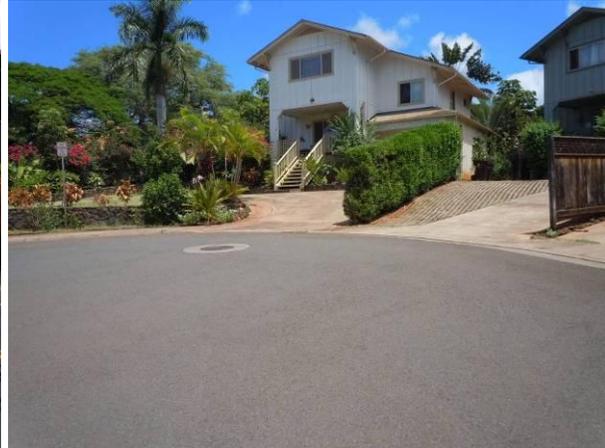
Haku Hale Place is a newer neighborhood than most of the surrounding area (built in 1997). The dead-end road serves 26 houses, with a 60-foot cul-de-sac as a turnaround. The road was designed with two 8-ft wide lanes, and one 8-ft wide on-street parking lane all along the south side. The road is crowned, and stormwater is directed into curb inlets that are connected to the Lower Honoapiilani Rd drainage system, HBP-1.

This road is wider than typical for a two-lane road because a parking lane was included (left); the cul-de-sac is completely impervious with a 60-ft diameter (right).

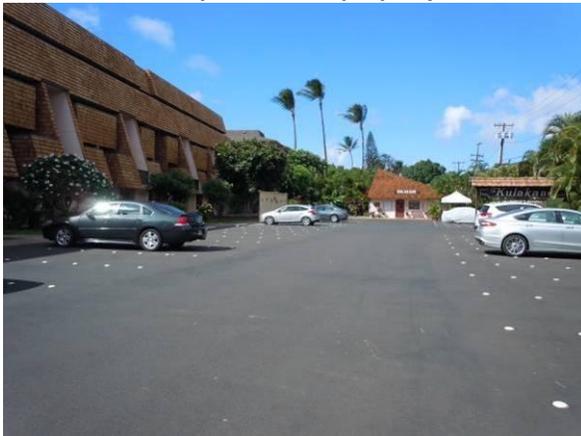
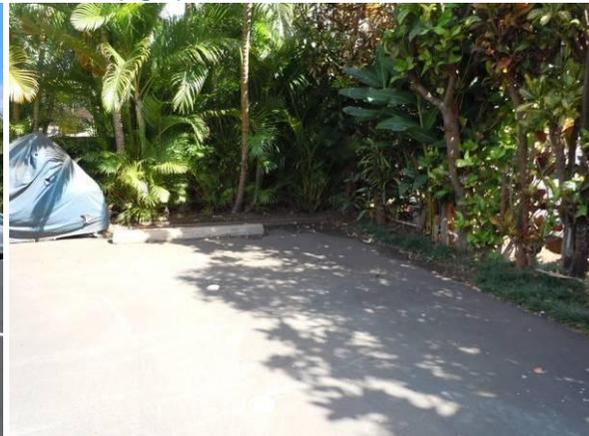
Built in 1970, Kulakane is an oceanfront condominium with almost 0.5 acres in the watershed, 68% of which is impervious parking lot. From the field visit, it appears that the rooftop runoff does not discharge onto the parking lot, but is contained in landscaped areas and/or flows toward the ocean. The large parking lot has no stormwater infrastructure; instead, all of the runoff flows toward the low point at the southeastern corner and out onto Lower Honoapiilani Rd.

The extensive parking lot at Kulakane with no stormwater infrastructure (left); all runoff from the parking area drains to this low point on the property and out into the street (right).

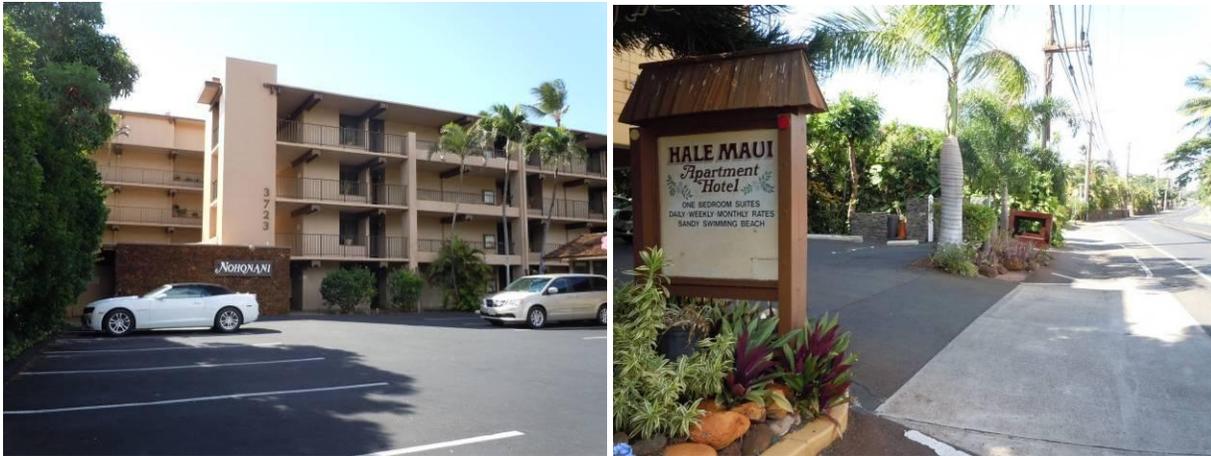
The parking area for the Nohonani Condos and the rooftop from the Hale Maui contribute runoff to the drainage area for HBP-1 without any visible on-site stormwater management. The

The Nohonani Condominiums parking lot drains out to Lower Honoapiilani Rd (left); a portion of the roof and parking area of the Hale Maui Apartment Hotel also drains into our study area (right).

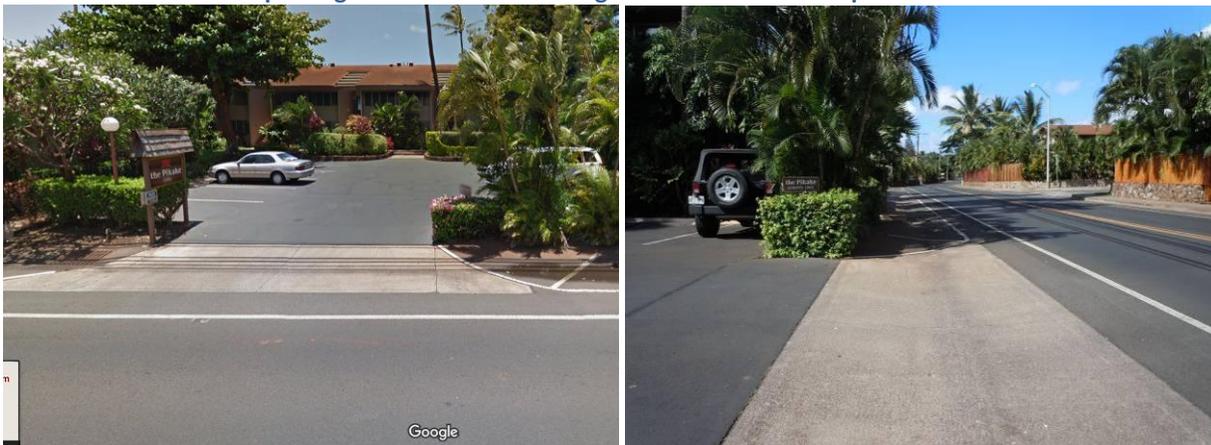
The Pikake is a condominium complex constructed in 1966 where the front portion of the property drains toward Lower Honoapiilani Rd while the back portion drains toward the ocean. The portion of the site in our watershed is 0.29 acres that is 65% impervious.

Runoff from the Pikake parking lot flows down to the gutter on Lower Honoapiilani Rd.

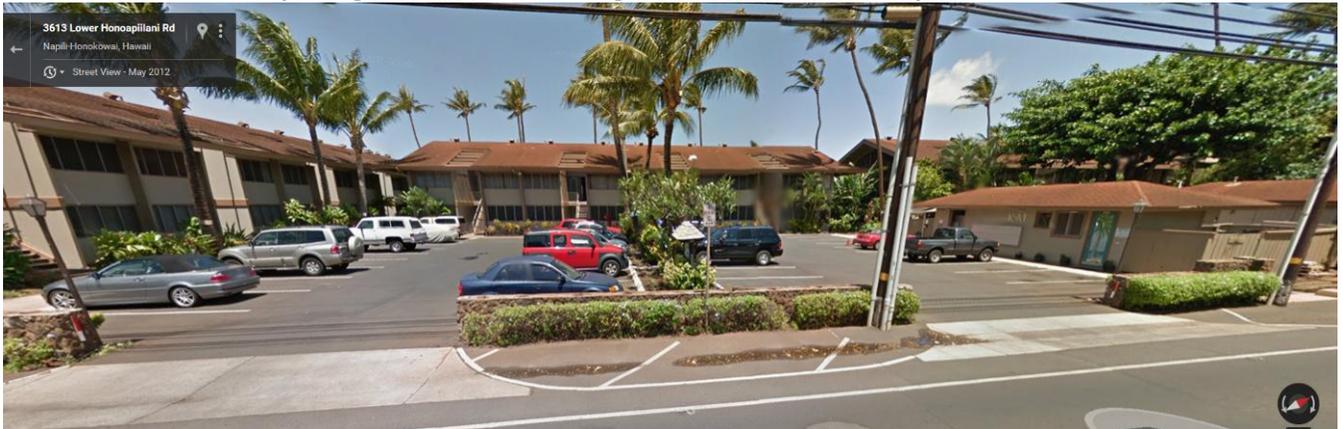
**Runoff from the Hale Kai parking lot flows down to the gutter line on Lower Honoapiilani Rd.**

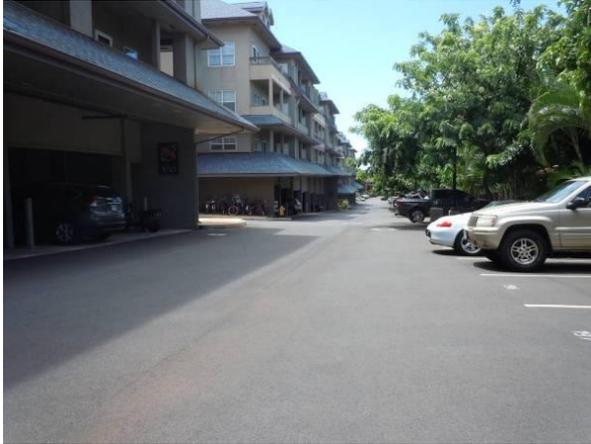
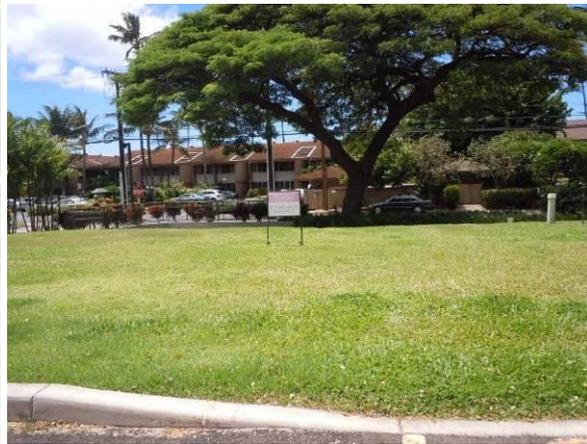
The Breakers is the most recent development in the watershed, built in 2008. Not surprisingly, it is also the only development that has an existing stormwater management practice. The almost 3-acre development is 72% impervious. The rooftops have gutters and downspouts directed to the driveway/parking area. All of the runoff is directed via catch basins/storm drains into an extended dry detention basin located along Lower Honoapiilani Rd. The basin has a hardened (with rocks) low-flow channel that carries runoff from small events directly into the adjacent street storm drain network with no filtering or infiltration; it appears that runoff from larger events will be detained in the basin to some extent, providing some flooding attenuation. The Breakers has a large, grassy open space adjacent to the basin, but existing signage indicated that an additional building would be constructed in this area.

Downspouts from the roofs direct runoff onto the parking area (left); another building is slated to be constructed on the remaining open space at this site (right).

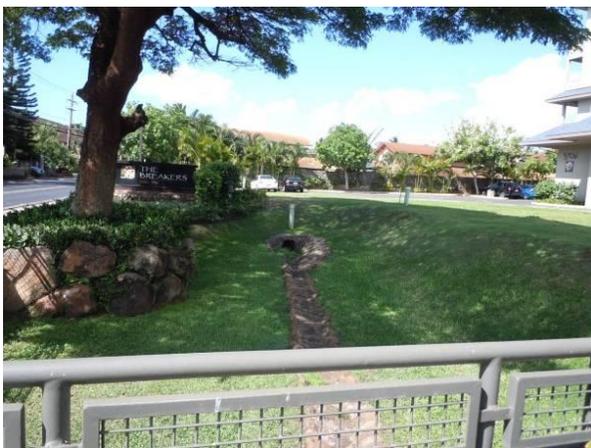
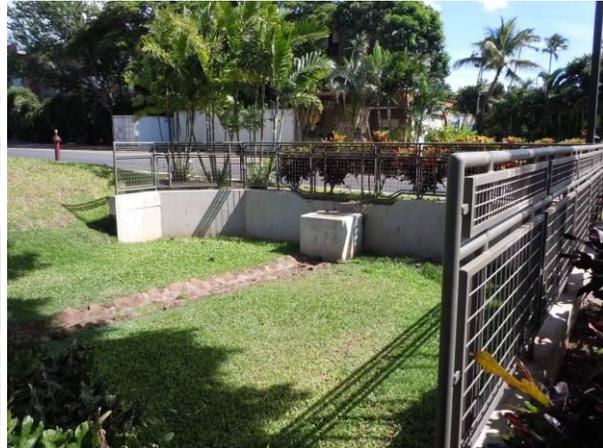
An extended dry detention basin helps manage runoff from The Breakers (left); a concrete outlet structure controls flow rates out of the basin and into the storm drain system in Lower Honoapiilani Rd (right).

The Breakers is the newest development in the watershed (2008) and has the only observed stormwater BMP – an extended detention basin. There is a total of 2 acres of impervious cover that contributes runoff to the small basin immediately adjacent to Lower Honoapiilani Rd. This includes almost 1 acre of roof top that is directly connected to the parking area via downspouts discharging to the pavement. Runoff is collected by a series of catch basins and directed into the detention basin. Low flows are conveyed with a hardened (appears to be a mortared rock base) low-flow channel with little to no detention before flowing out the orifice in the overflow structure. Runoff from larger storm events will be detained in the basin until the water reaches the top of the overflow structure, where it will flow through the grate and into the storm drain system in the road. The proposed retrofit for this site is to enlarge the existing basin utilizing the open lawn next to the basin (currently slated for future development), providing water quality treatment features such as a sediment forebay for pretreatment, longer flow path for low flows, wetland vegetation to filter and take up nutrients, and greater flood storage for larger events. In addition, the rooftop runoff should be collected in cisterns and reused as much as possible. Allowing the clean roof runoff to flow over a parking lot, picking up all the associated pollutants, is a lost opportunity. This could also provide a good example for other developments in the watershed – almost all buildings have gutters and downspouts for roof runoff, and yet no cisterns or rain barrels were observed. This project does have potential for public education given its location next to the main road, but it is a private development where future buildings are proposed, presenting an implementation challenge.

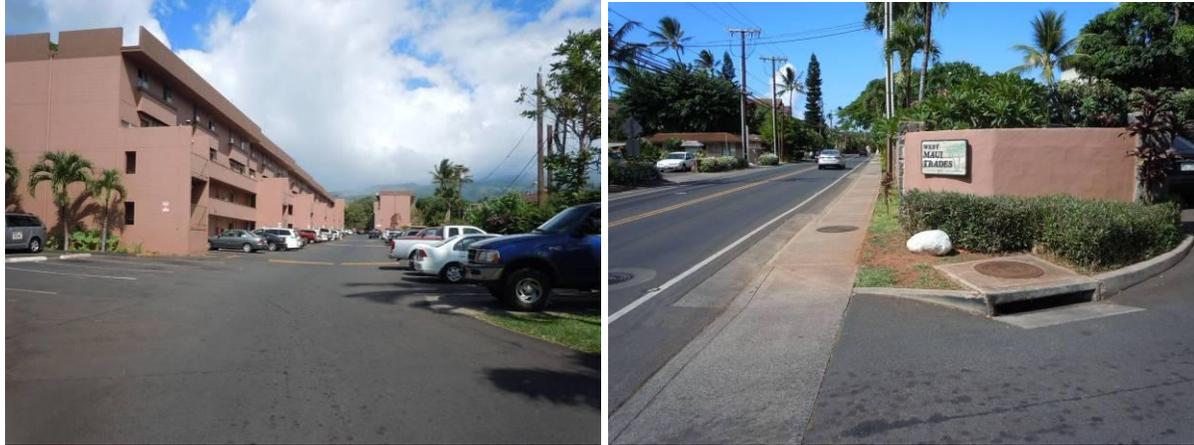
West Maui Trades is a 1.8-acre property that was developed in 1978. The site is over 80% impervious with a steep parking area. The rooftop runoff appeared to be directed to the parking area, and no stormwater infrastructure was visible anywhere on site. All runoff appears to enter the Lower Honoapiilani Rd drainage system via curb inlets near the road.

Runoff from West Maui Trades flows down the steep parking area to curb inlets near the road.

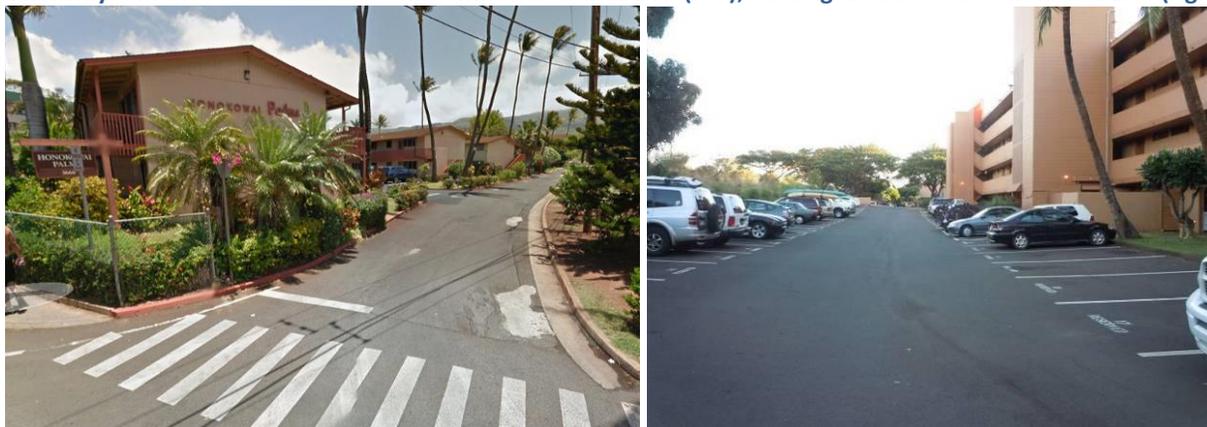
Honokowai Palms and Honokowai East are two condominium complexes accessed by the same driveway. Both have large expanses of parking and rooftops, as well as outdoor pools. Honokowai East also has a large tennis court, accounting for over 20% of its land area. No stormwater infrastructure was visible for either of these properties, so it is assumed that all runoff flows down the driveway to Lower Honoapiilani Rd.

Driveway entrance to Honokowai Palms and Honokowai East (left); Parking area behind Honokowai East (right).

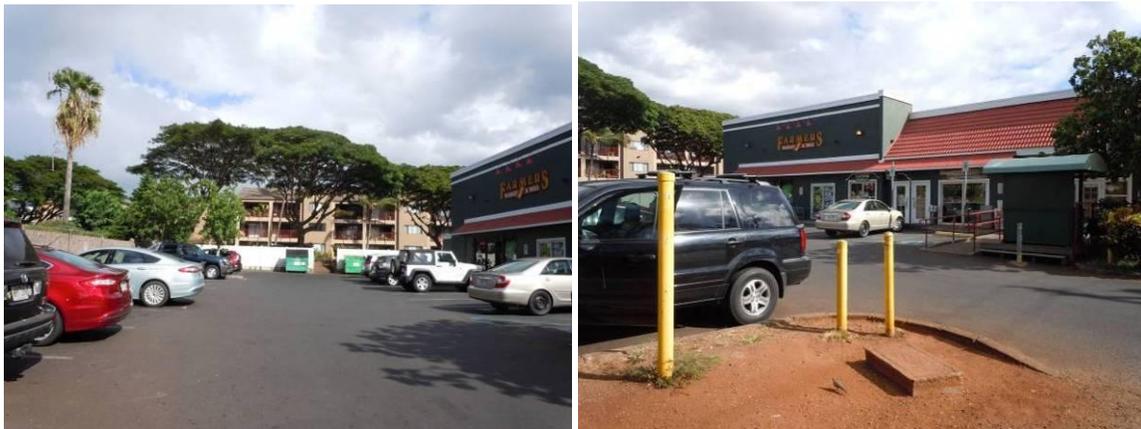
The Farmer’s Market Plaza is one of only two commercial properties in the study area. This area was developed in 1975 and hosts an outdoor market three days a week, as well as an indoor market open all week. There are also a few shops in the front of the building along Lower Honoapiilani Rd. There was no visible stormwater infrastructure, and it appeared that the parking lot and rooftop runoff drains overland into the road and catch basins adjacent to HBP parking lot.

**The Farmer’s Market Plaza parking lot (left) and building (right).**

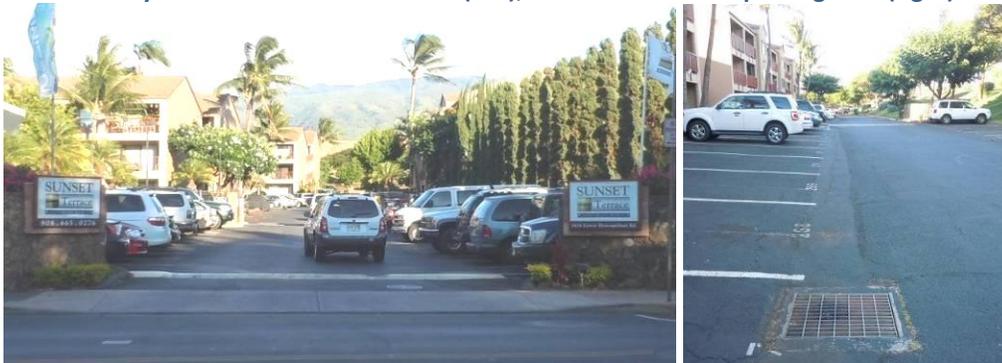
Sunset Terrace is the largest development in the entire watershed. It was built in 1987 and is comprised of 12 condominium buildings, surrounded by parking areas. There is one pool on the property, as well as landscaping between and behind the buildings. This property has its own drainage network of a series of catch basins and storm drains that discharge into HBP-2, but there are no stormwater practices visible for water quality or flooding control.

**Driveway entrance to Sunset Terrace (left); catch basin in back parking area (right).**
